Evaluation of Ultra-High-Performance Fiber-Reinforced Concrete

CELIK OZYILDIRIM, Ph.D., P.E.
Principal Research Scientist

Final Report VCTIR 12-R1

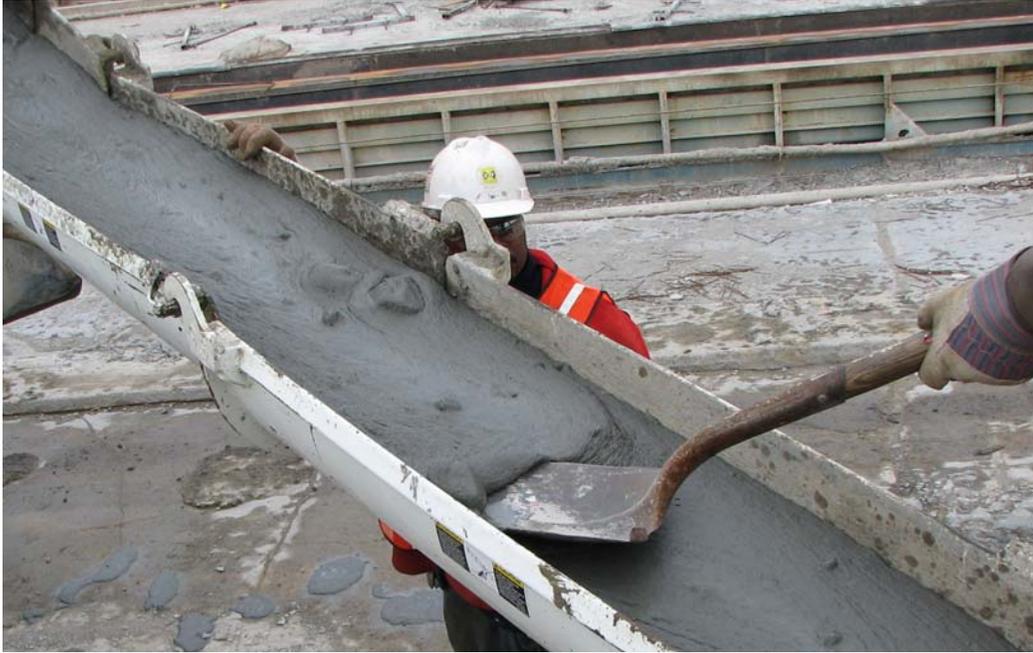
Figure 1. Large Cement Balls Were Seen During Discharge From Truck

Mixing was done in 4-yd³ loads in a stationary 6-yd³ twin shaft mixer at the batch plant. The mixer discharged the concrete to ready-mix concrete trucks. The prestressing bed was next to the central plant. Mixing time was longer than for conventional mixtures. The loading time, extended mixing for thorough blending, and discharge into the truck took about 20 to 25 min for each batch. Although the twin-shaft mixer is very efficient in providing thorough mixing, cement balls as large as 9 in (shown in Figure 1) were seen during the discharge from the truck. The cement balls were attributed to the exposure of the bags to moisture during storage, causing prehydration. The large cement balls were hand picked and discarded, and the small ones had a tendency to rise to the surface of the beam as shown in Figure 2.

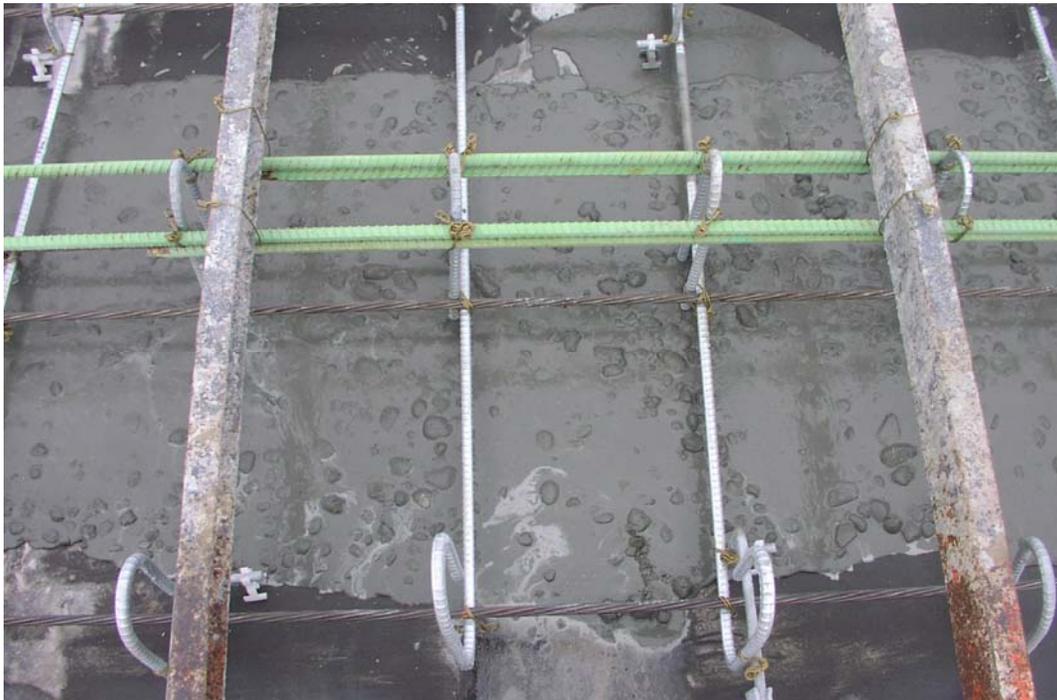
Figure 2. Small Cement Balls Rose to Surface

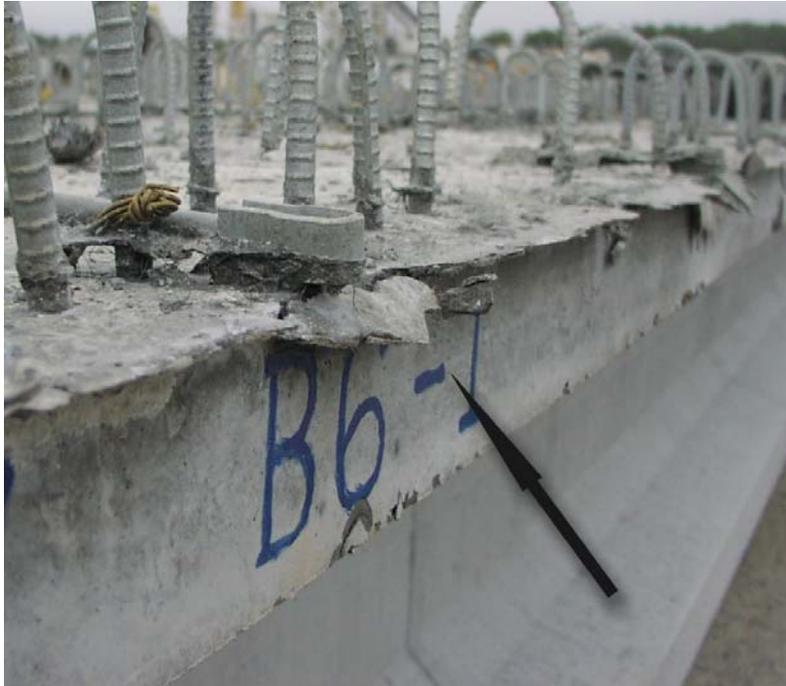
Figure 3. Extra Ultra-High-Performance Concrete Stuck to Form After Hardening

The mixture was discharged into one end of the beam molds from the trucks. It was very cohesive but was able to flow without the need for consolidation; i.e., it was self-consolidating. However, to eliminate surface blemishes, expedite the flow, and minimize delays, limited external vibration was applied, each time with a 1- or 2-sec duration. Vibration was limited because of concerns with fiber orientation and dispersion. During removal of the steel forms it was noted that extra UHPC flowing to the top of the form had bonded strongly to the form after hardening, making the removal of the form very difficult, as shown in Figure 3. Fibers protruding at the finished surface required careful handling.
